P38 Range Rover viscous coupling replacement.

I could not find many photos of this job in progress, so I thought I'd share my experience for the benefit of others.

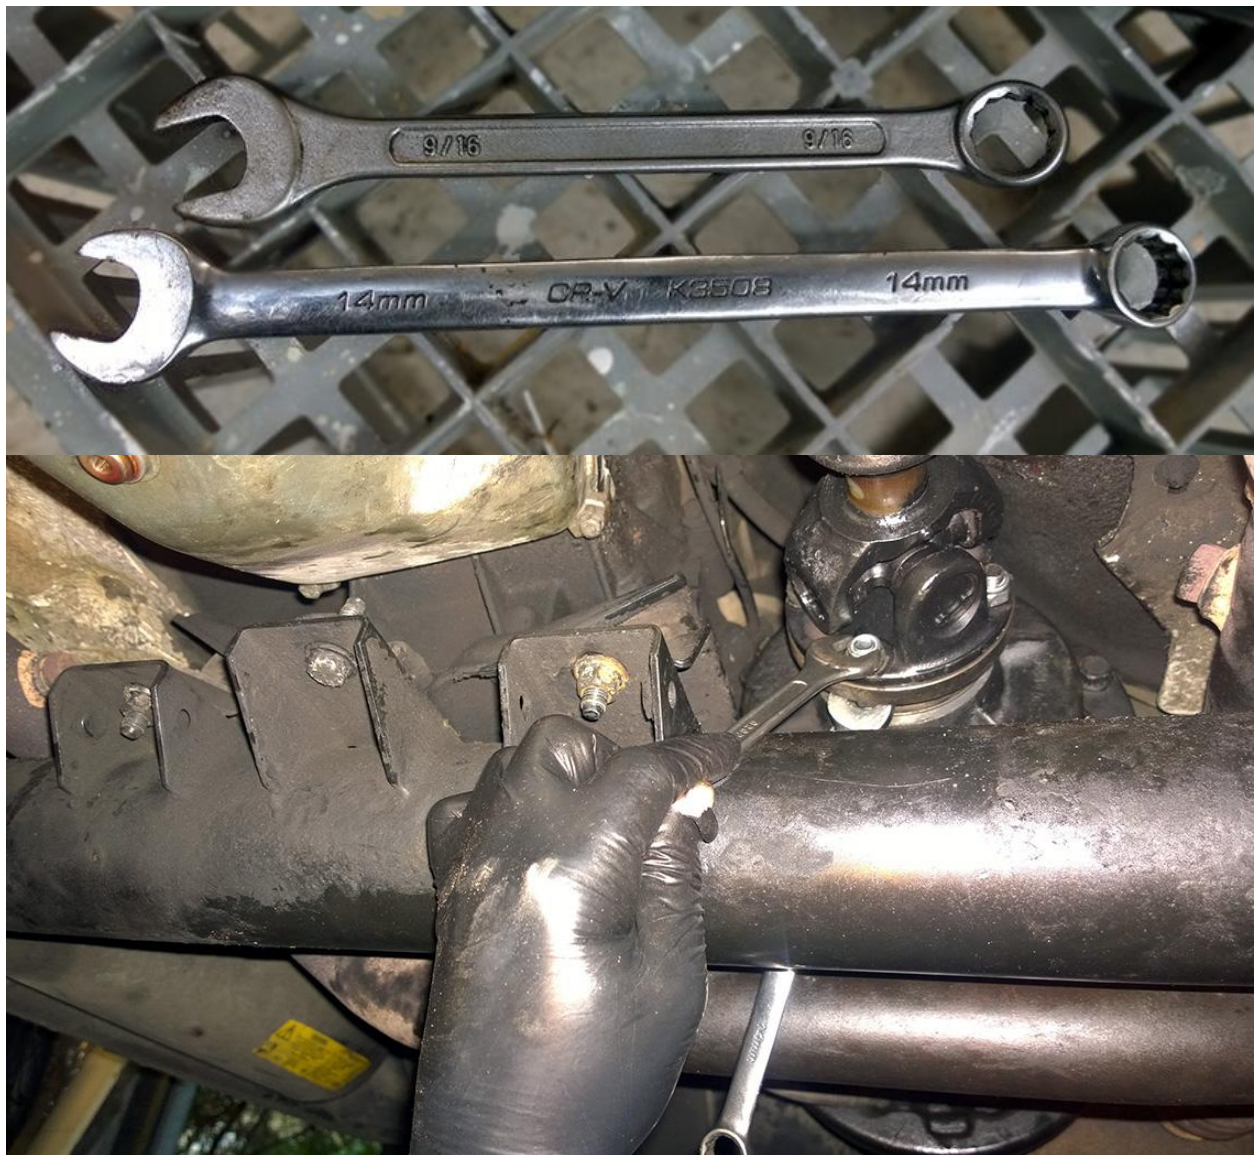
I found the longer 14mm on the bolt side held on well, and used the 9/16 on the nut side as it is easier to reposition after each turn. On the rear flange, if you get the shaft at just the right position it helps to give you a bit of extra movement with the spanner as shown.

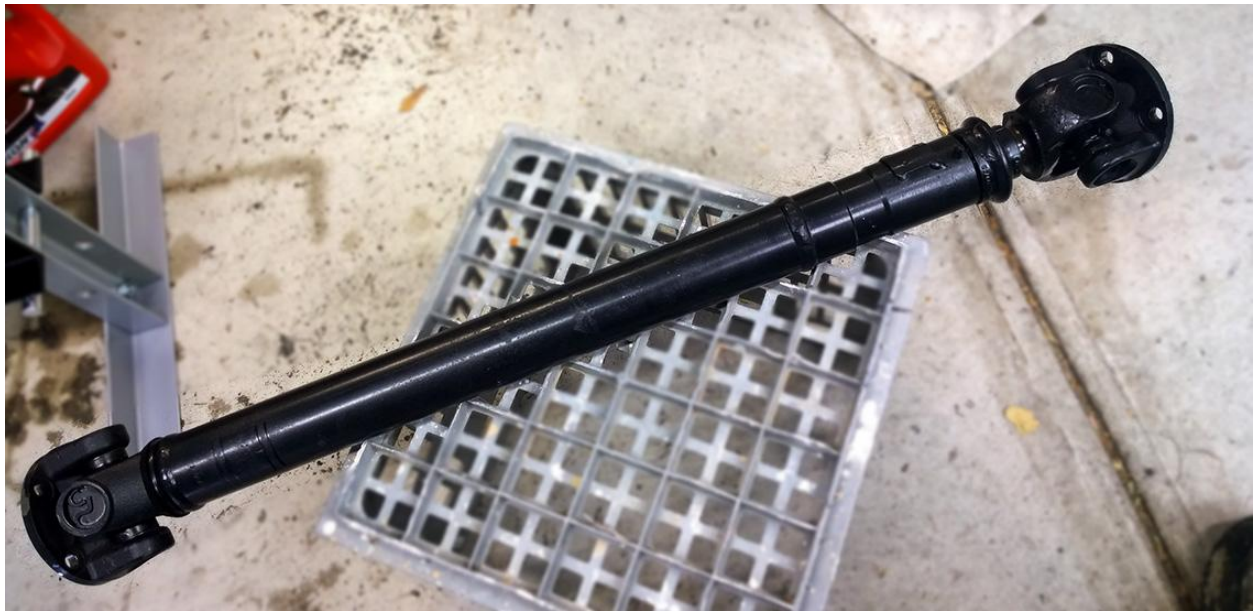
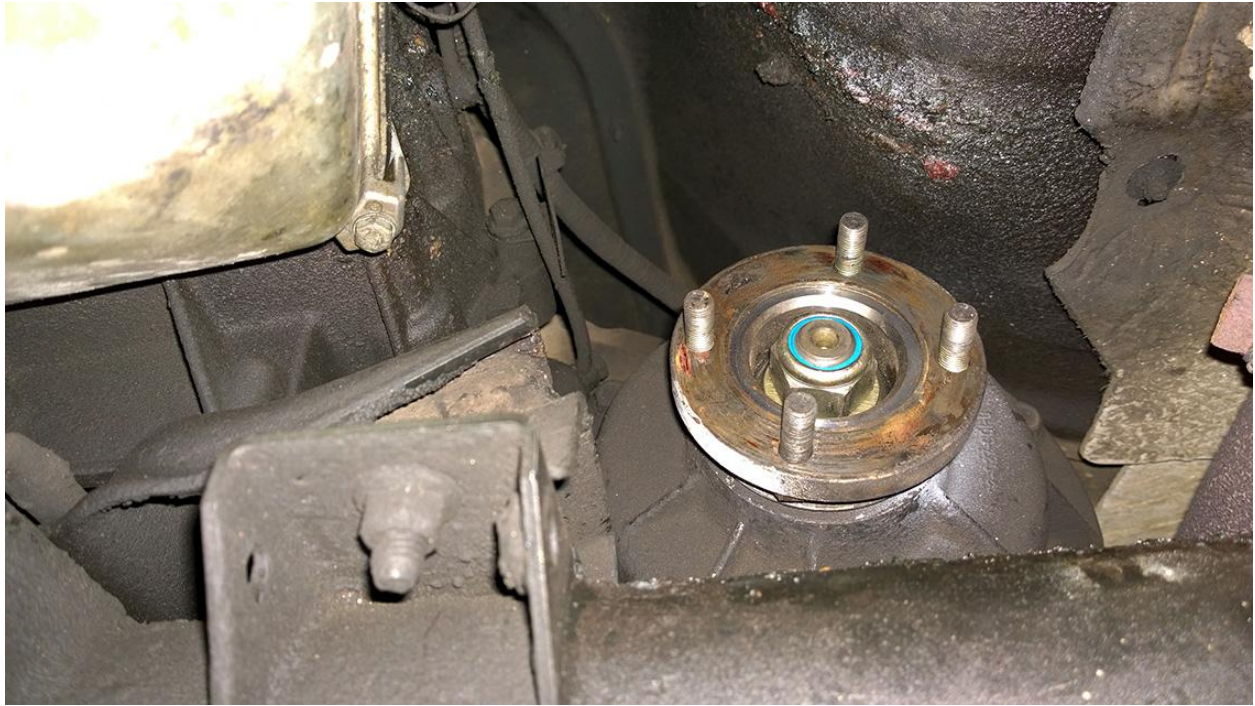
Once the shaft has been removed, you can see the flange bolt hiding above the cross member, with the viscous coupling housing behind that.

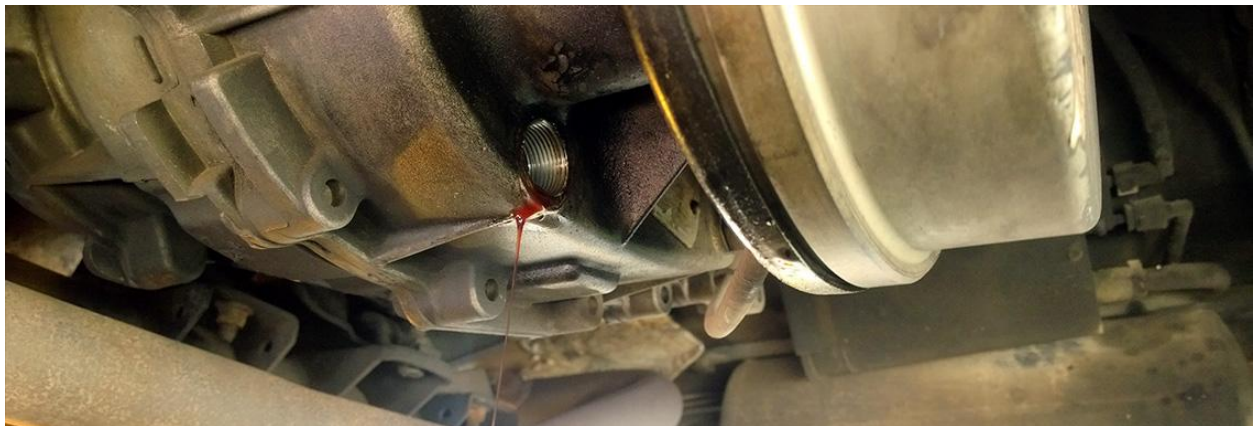
Easy enough, the end of a 1/2 inch ratchet fits straight in to the drain plug. Let it drain and refit plug.

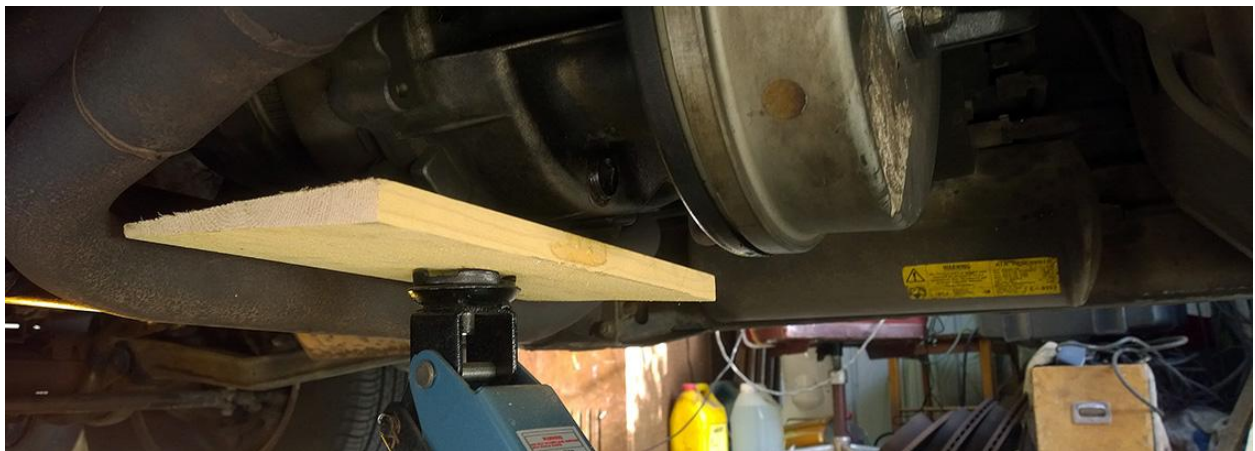
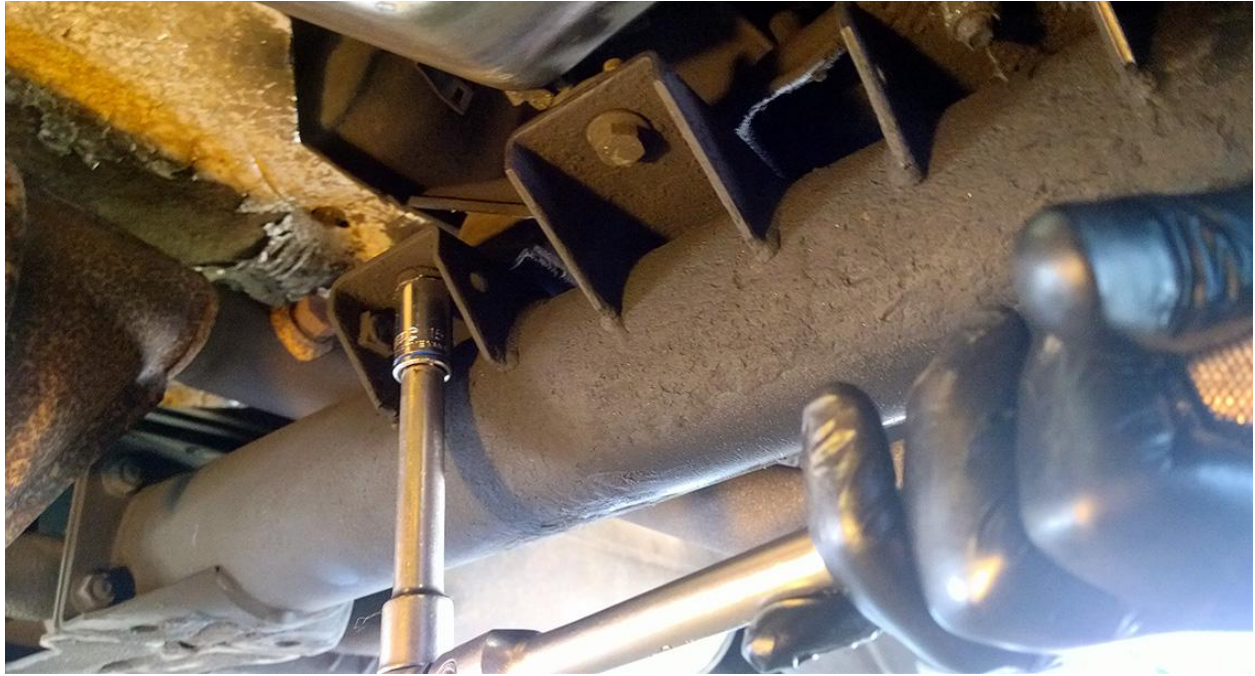
15mm socket with an extension needed here. The 2 middle bolts are attached to a small 'snubber' bar, which fits over the top. It comes out easily once undone.

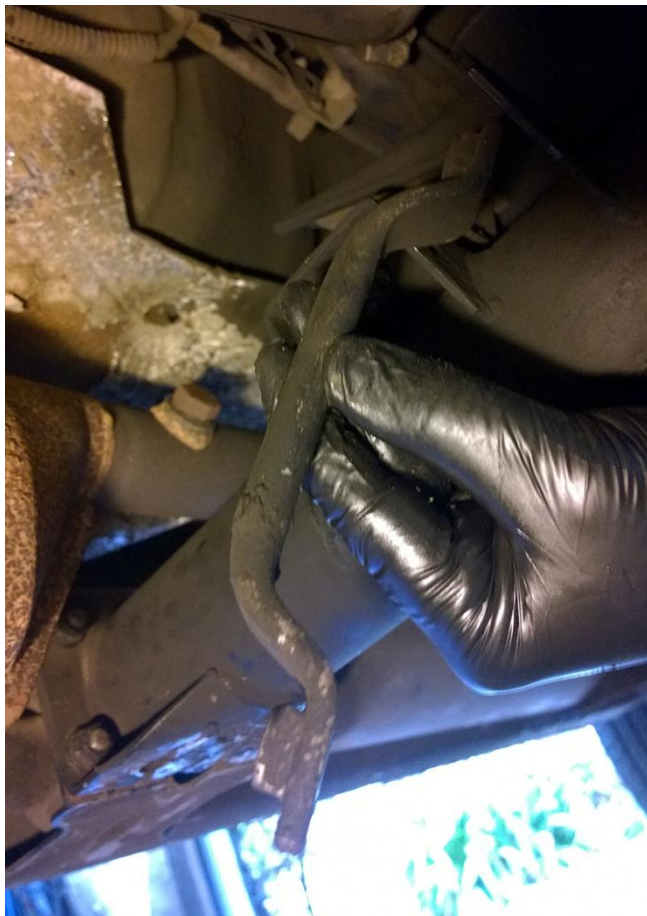
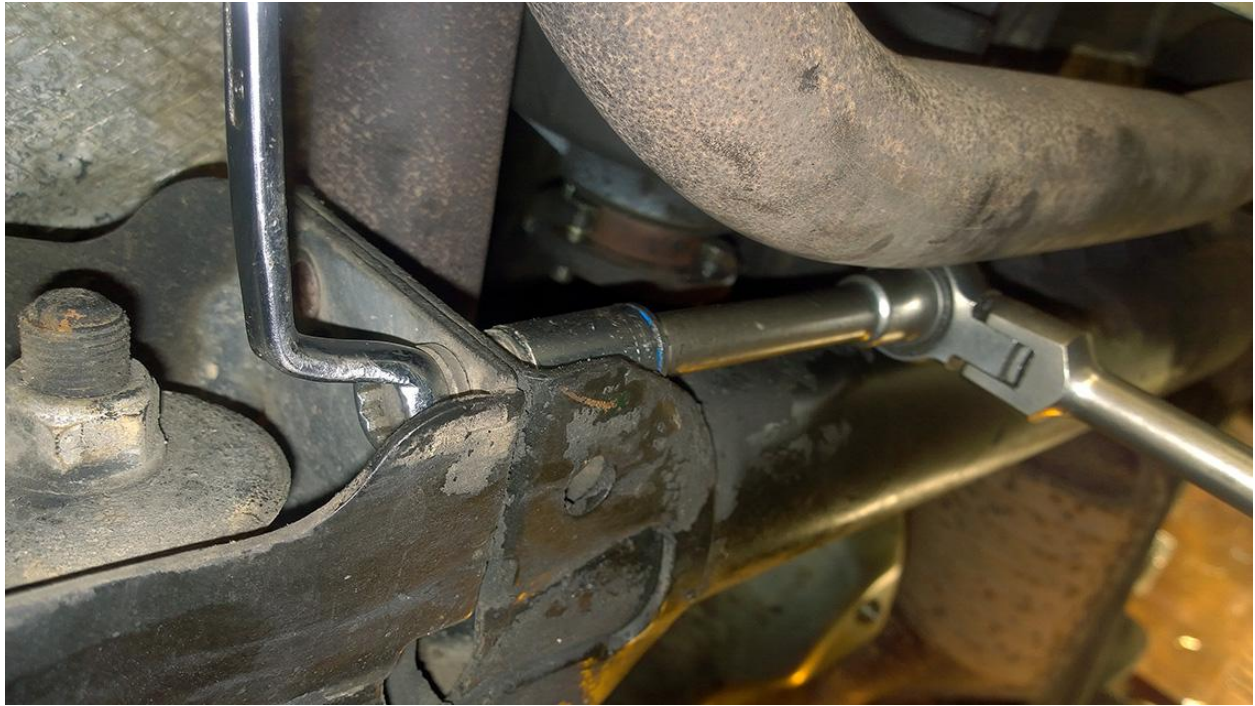
13mm ring spanner on the bolt end here, 15mm socket on the nut. Once everything is undone, it will require some gentle persuasion with a heavy hammer to get it moving. It will move fairly easily, just ease it out as straight as you can at both ends. It's not very heavy to handle once it's off.

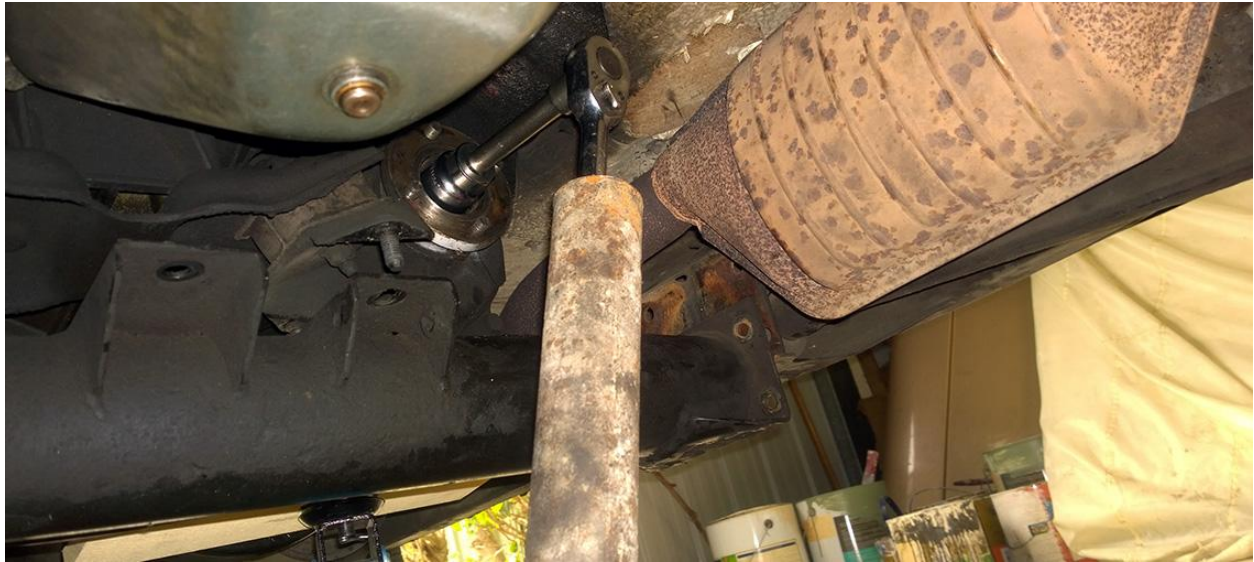
I thought it best to remove the flange bolt first, but I did not have my breaker bar with me, so I improvised with a ratchet and a length of water pipe as leverage. The trick here is to get out from underneath, get your feet onto the pipe and push with your legs! It came undone pretty easily with that method. 30mm socket required here. I did not need to brace the flange.

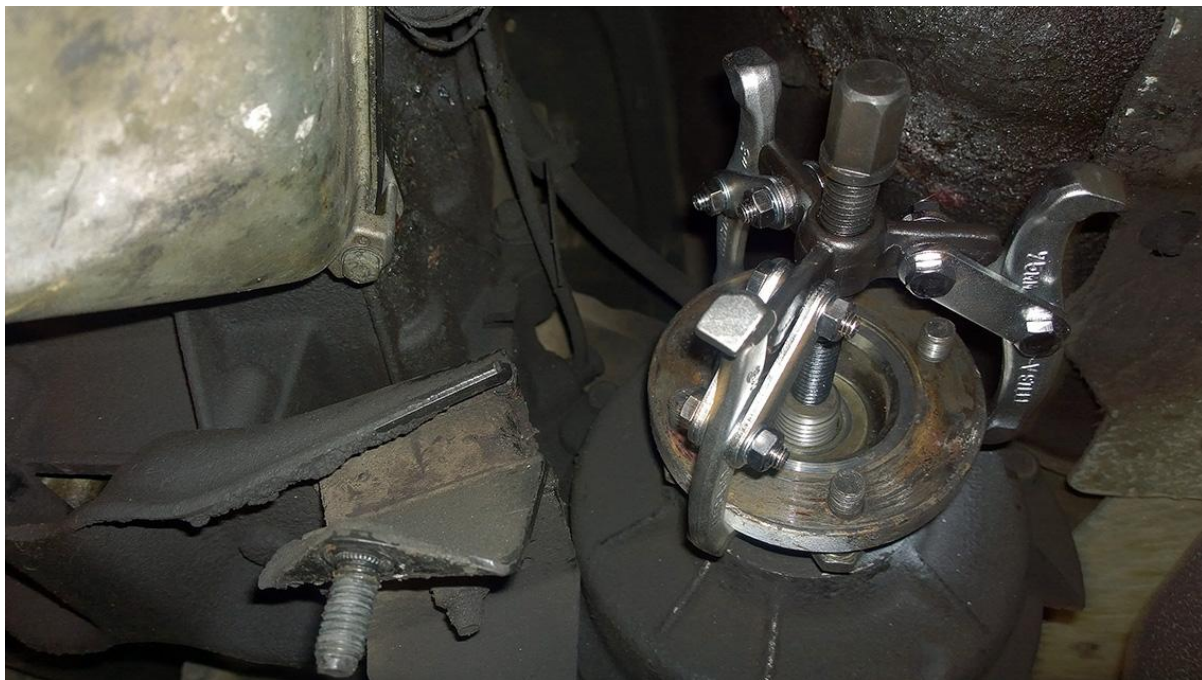
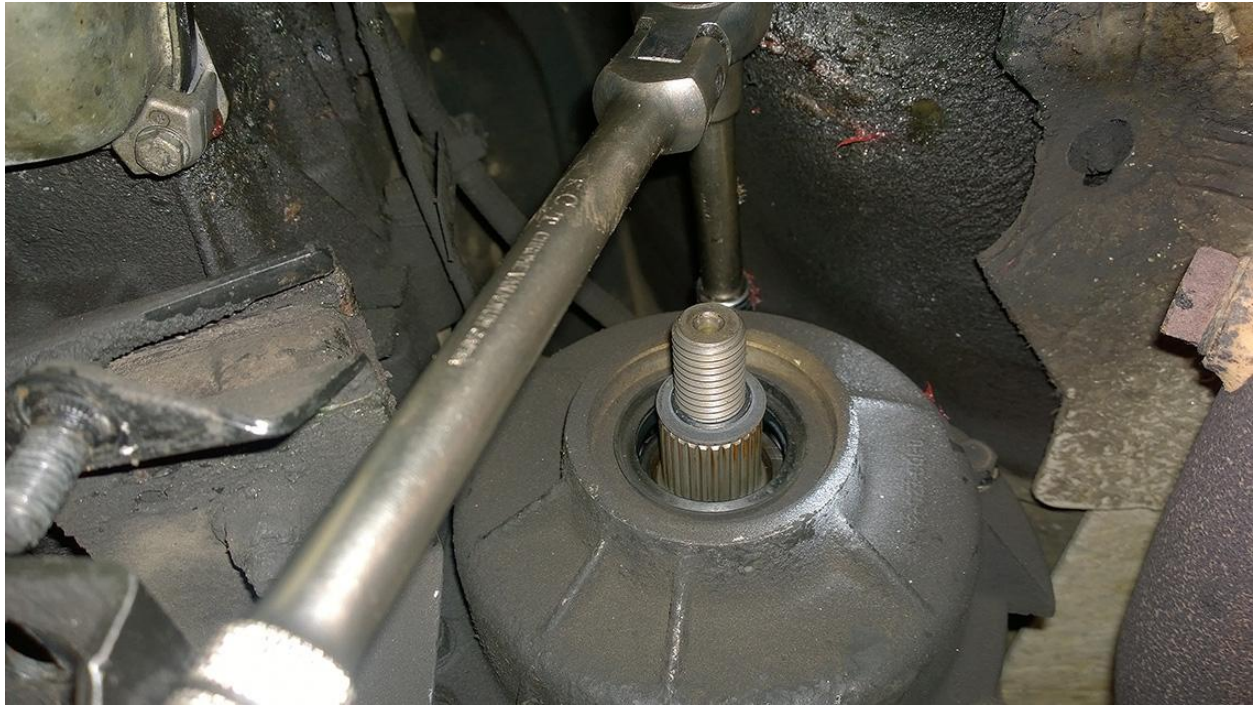
Next step is a 75mm gear puller to remove the flange. Mine came off pretty easily.

Next remove the 6 bolts around the vc housing. 15mm socket required and maybe an open end spanner for the left most bolt which is in a tough spot.

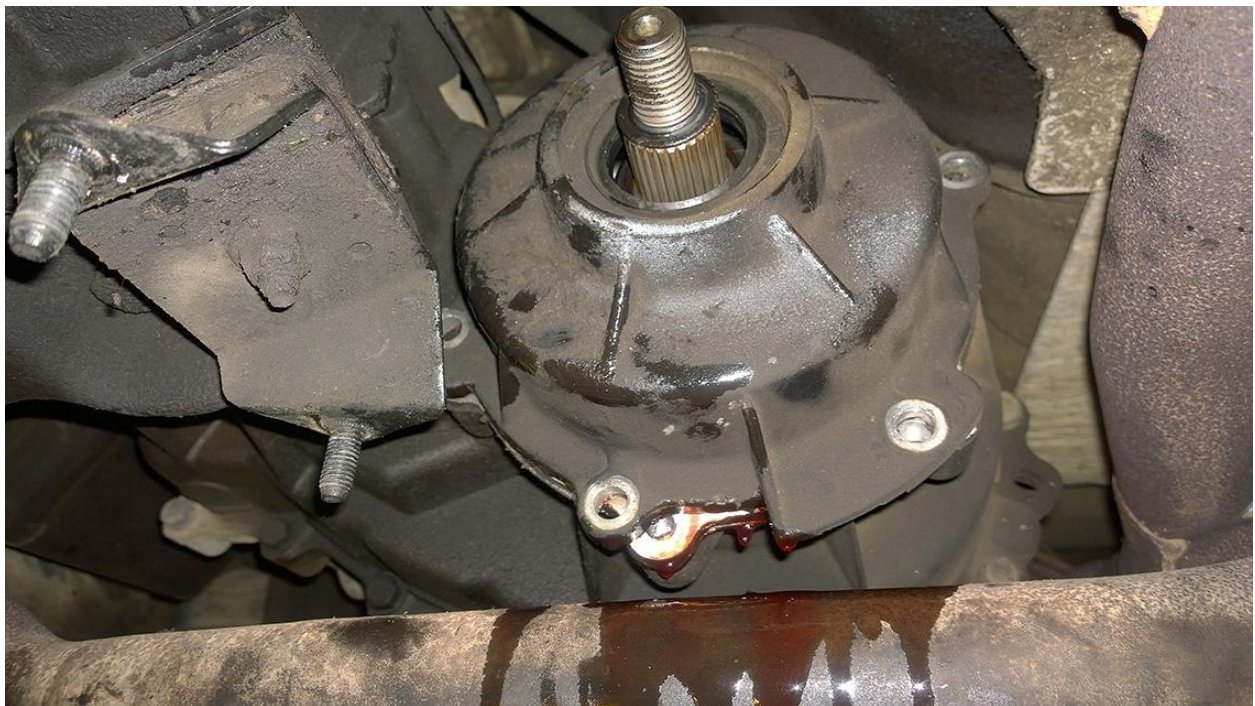
Once undone, a tap with a hammer and punch from behind will release the housing. Be ready for some stray ATF to leak out.

I had to give the VC shaft a few taps on the sides, top and bottom with a hammer to get it to release from the shaft. Once released it comes off easily.

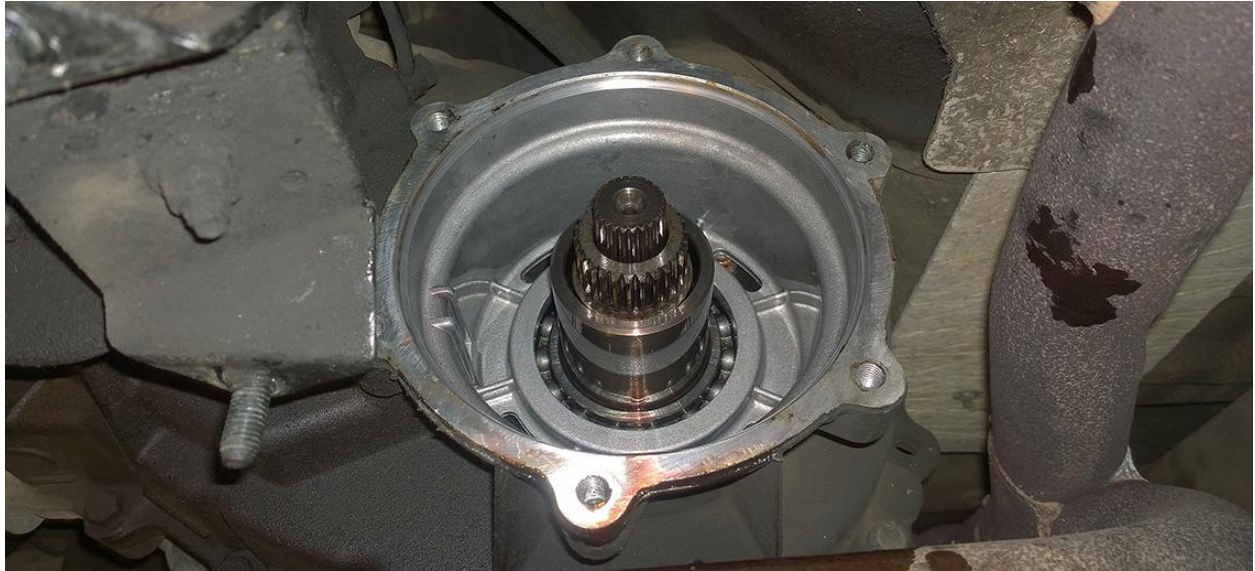
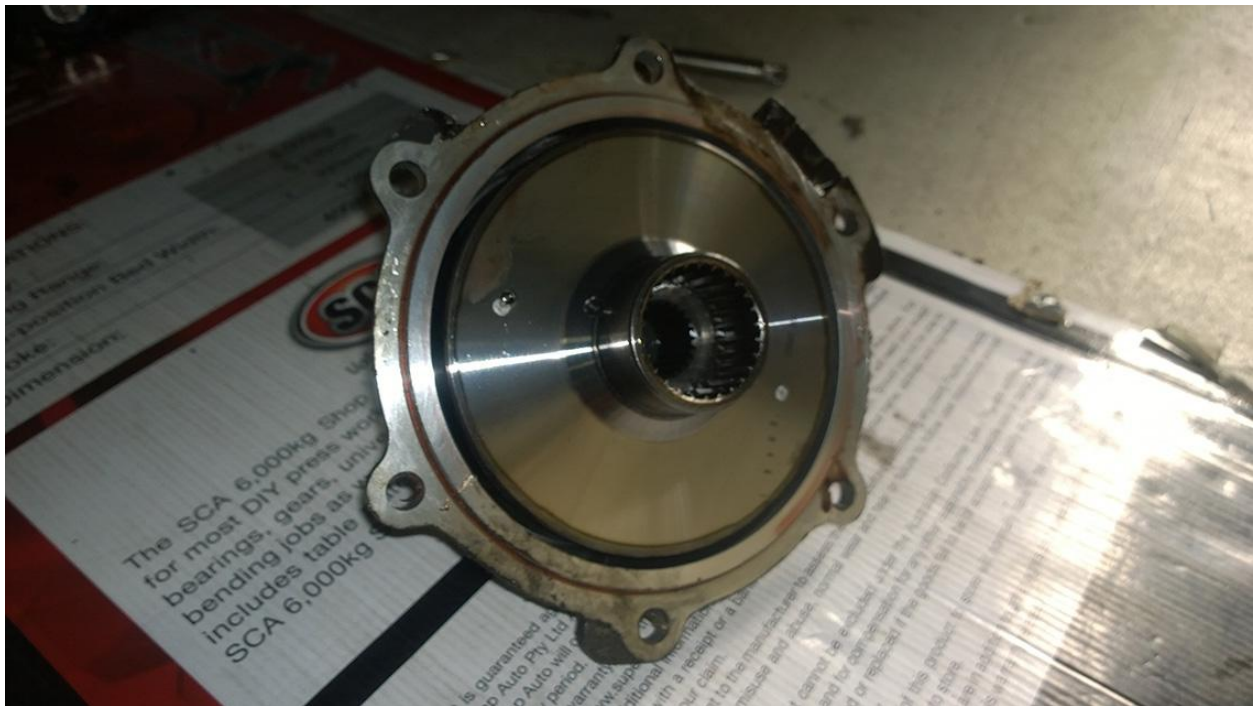
At last! VC removed. You can get out from underneath for a while now.

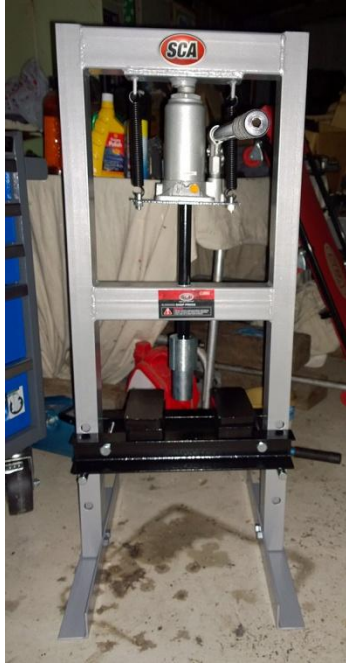
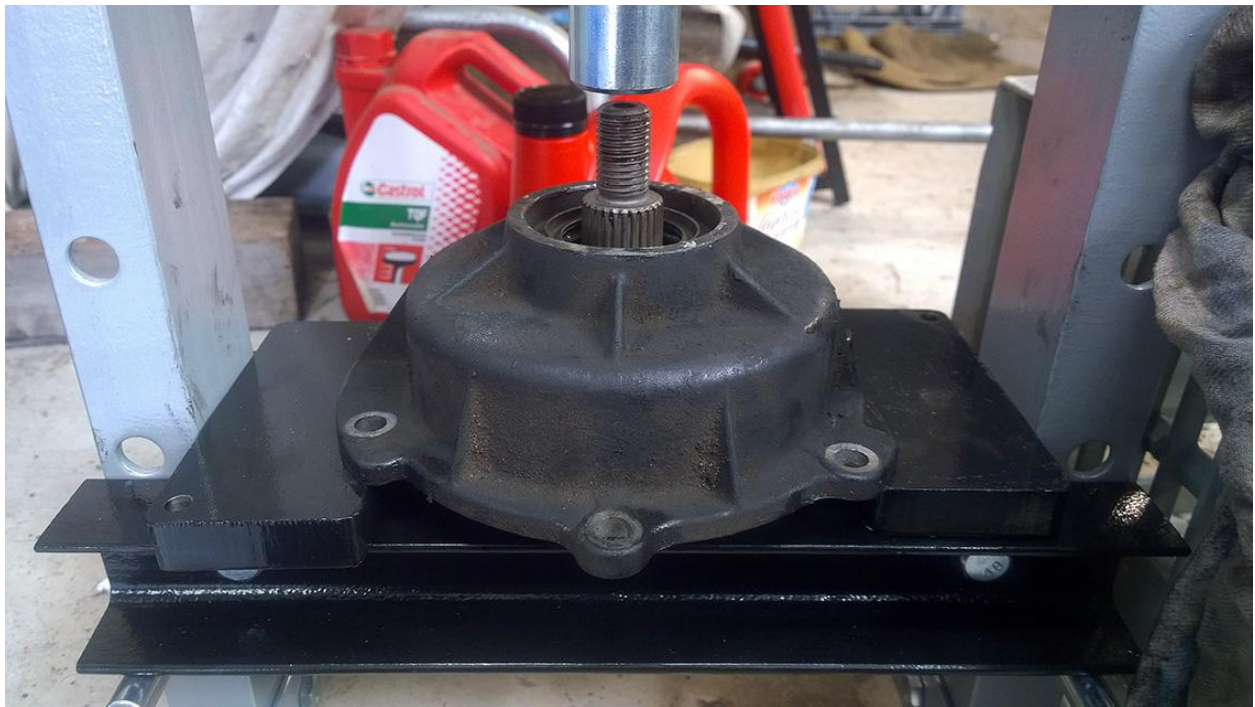
I got a 6000kg shop press on sale, I've wanted one for a while and this seemed like a good excuse to get one. It made the job a breeze, worth every cent.

The VC pressed out very easily with the press.

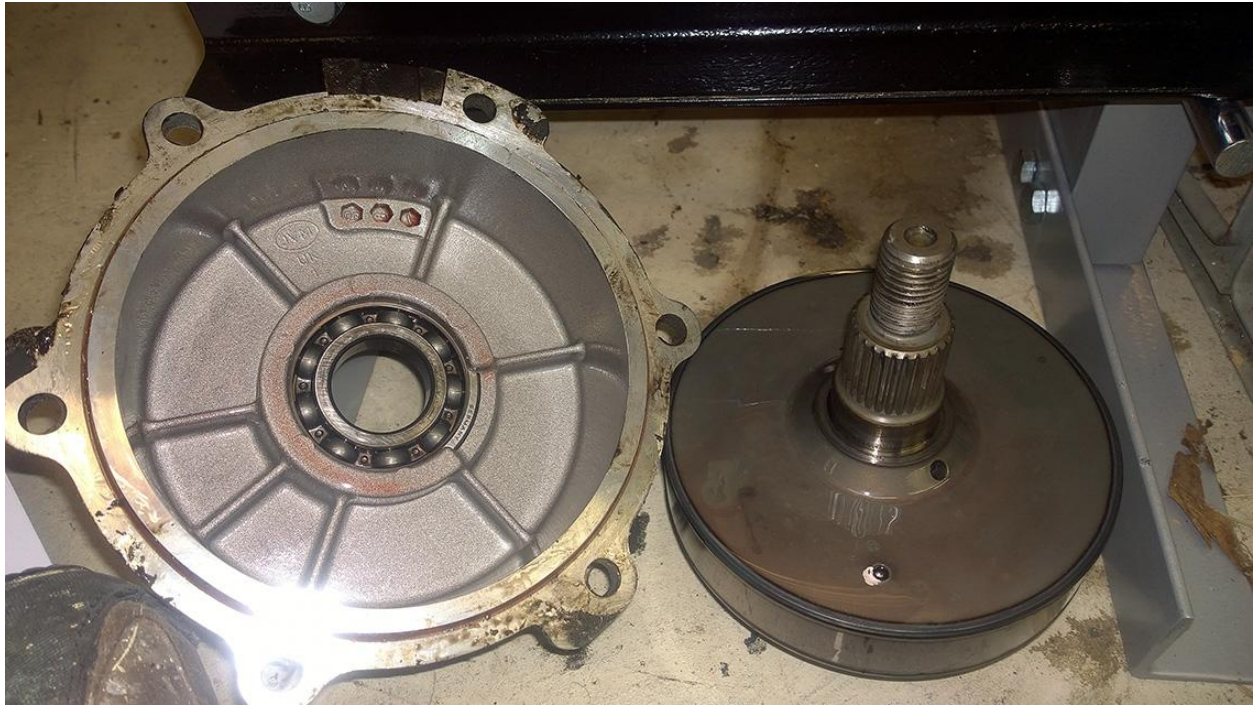
The old VC pressed out of the housing, you can see the bearing which I also replaced while I had it apart.

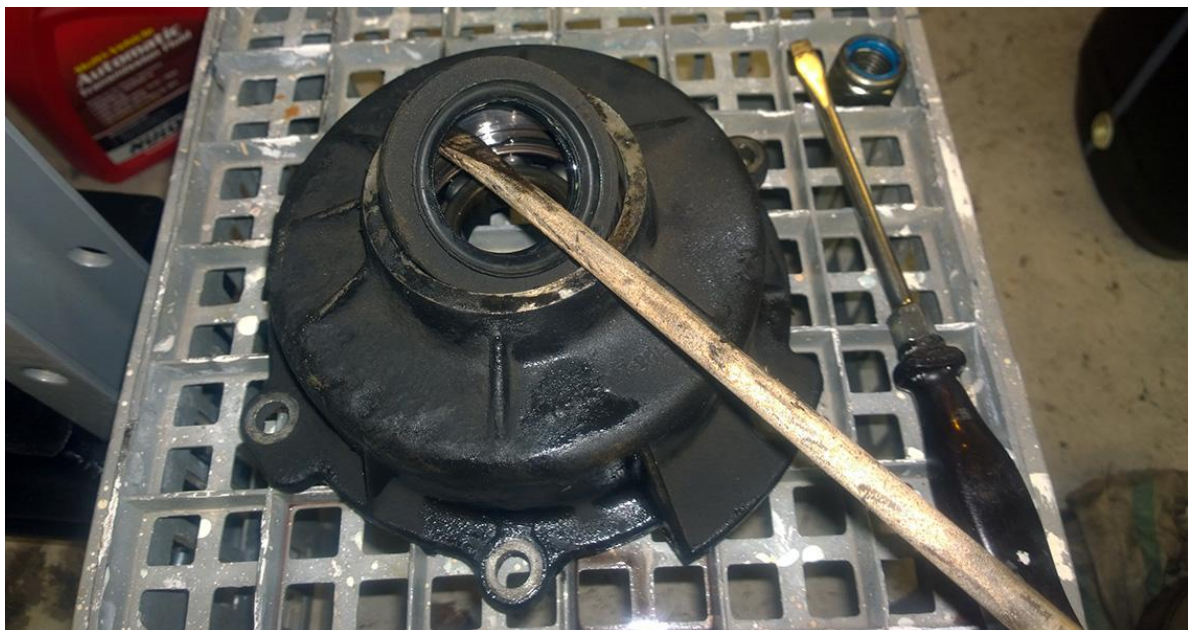
Next remove the oil seal. Flip the housing over and a long flat blade screw driver will lever the old seal out with ease.

I replaced my output bearing as well while it was apart. The bearing had some movement, so it was a good opportunity. Some circlip pliers are needed to remove the large circlip that holds the bearing in place.

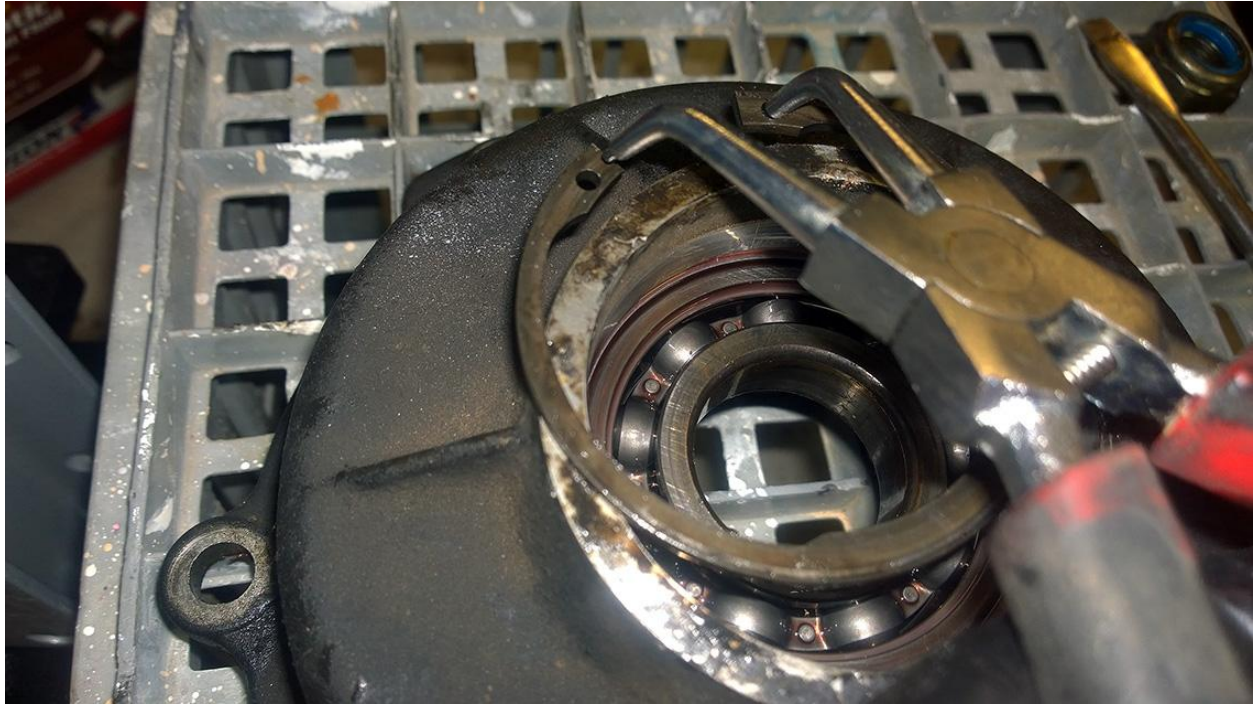
Next press out the old bearing.

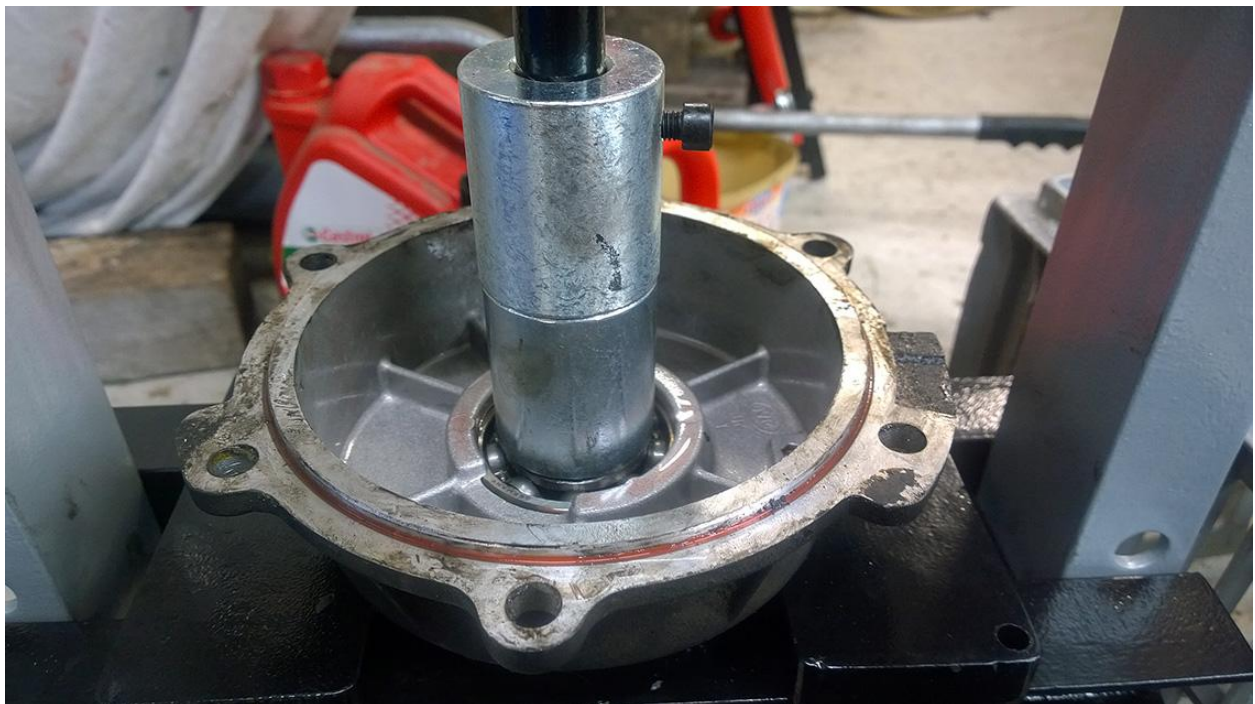
Housing with everything removed.

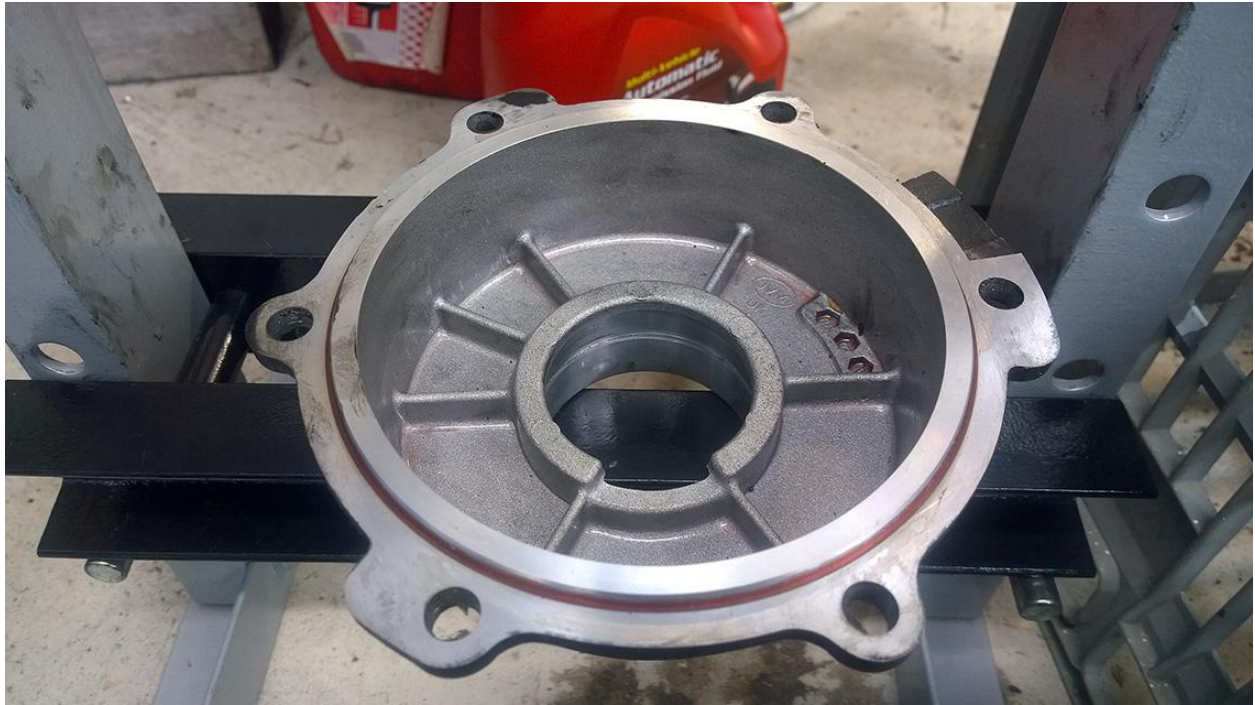
Top view.

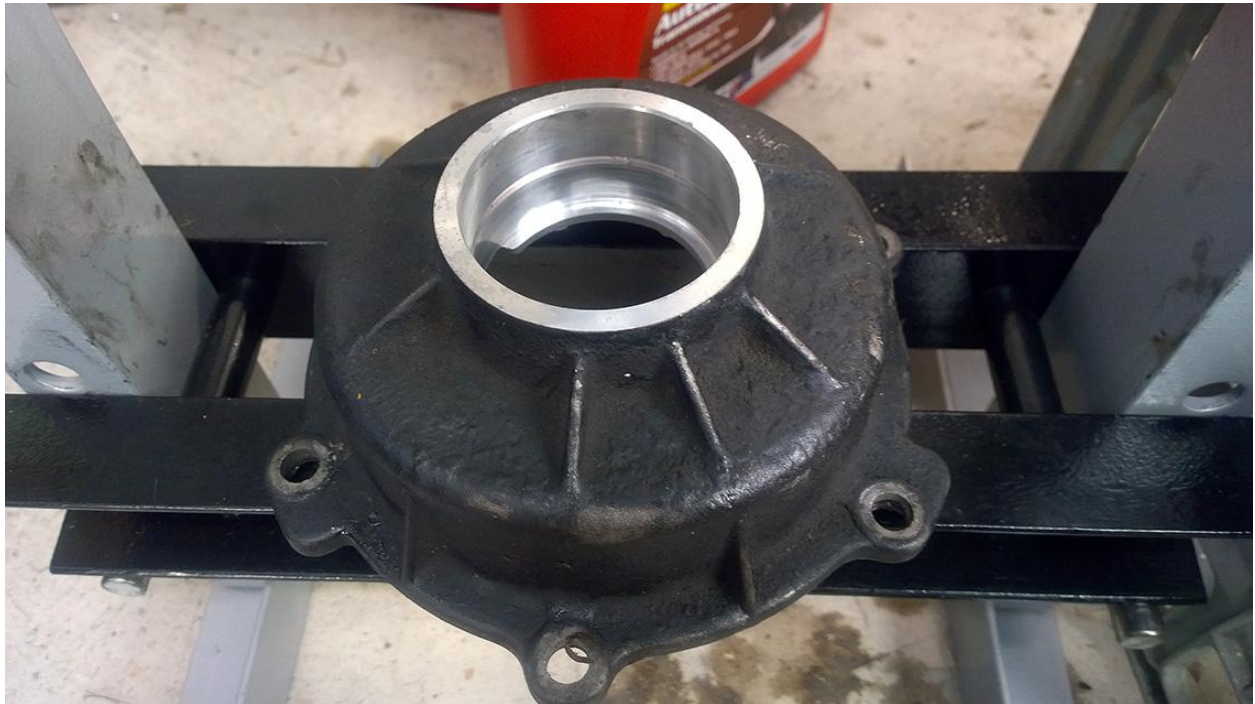
Next press in the new bearing on the outer race only, you can damage the bearing if you press the center part.

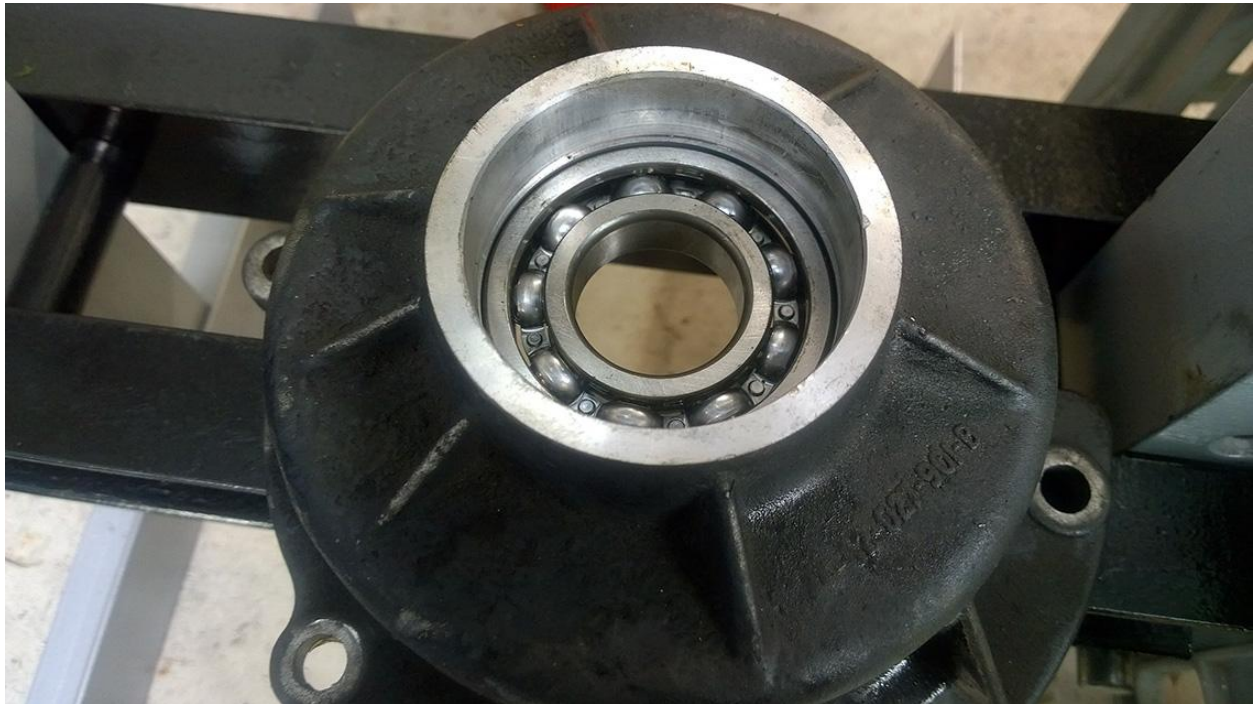
Replace the circlip.

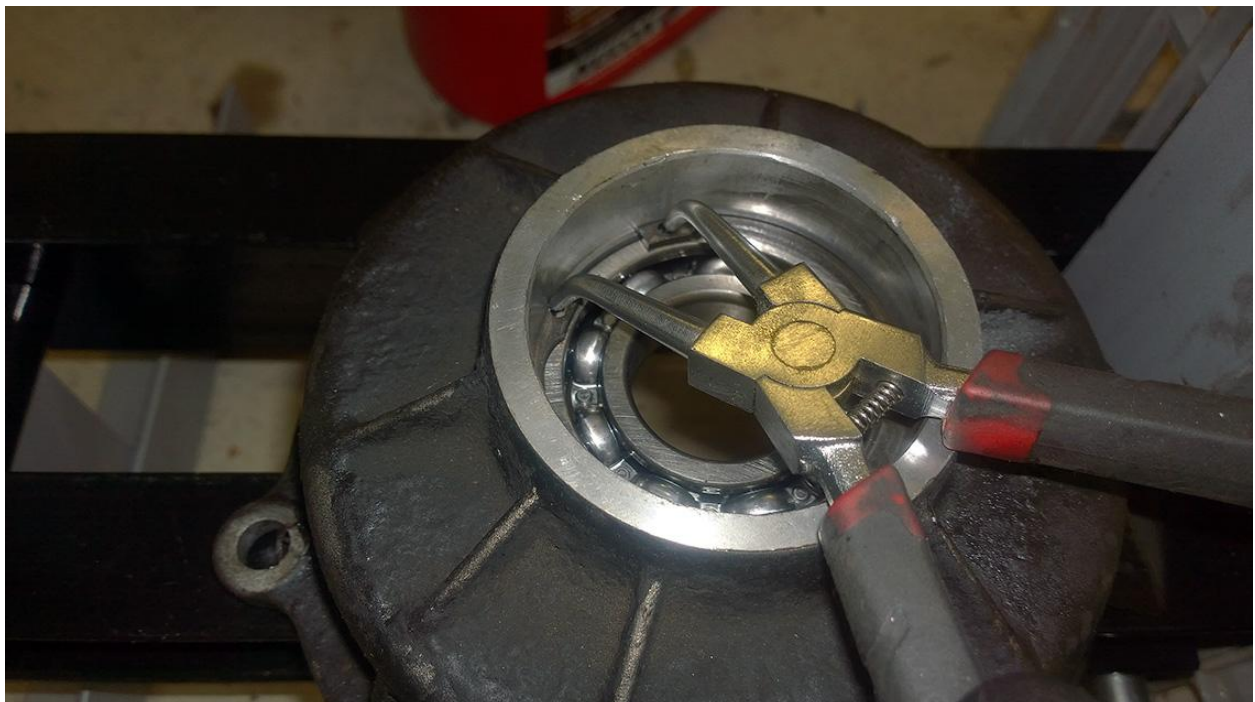
Press in the new oil seal.

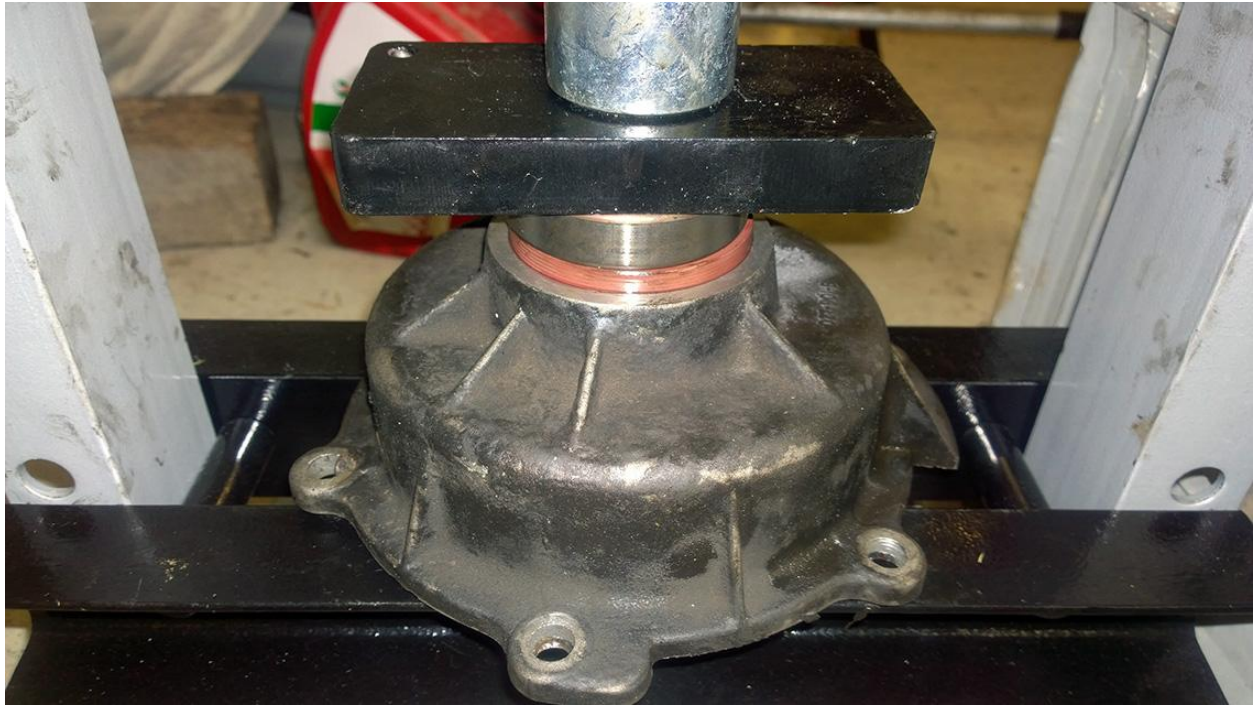
Oil seal correctly seated.

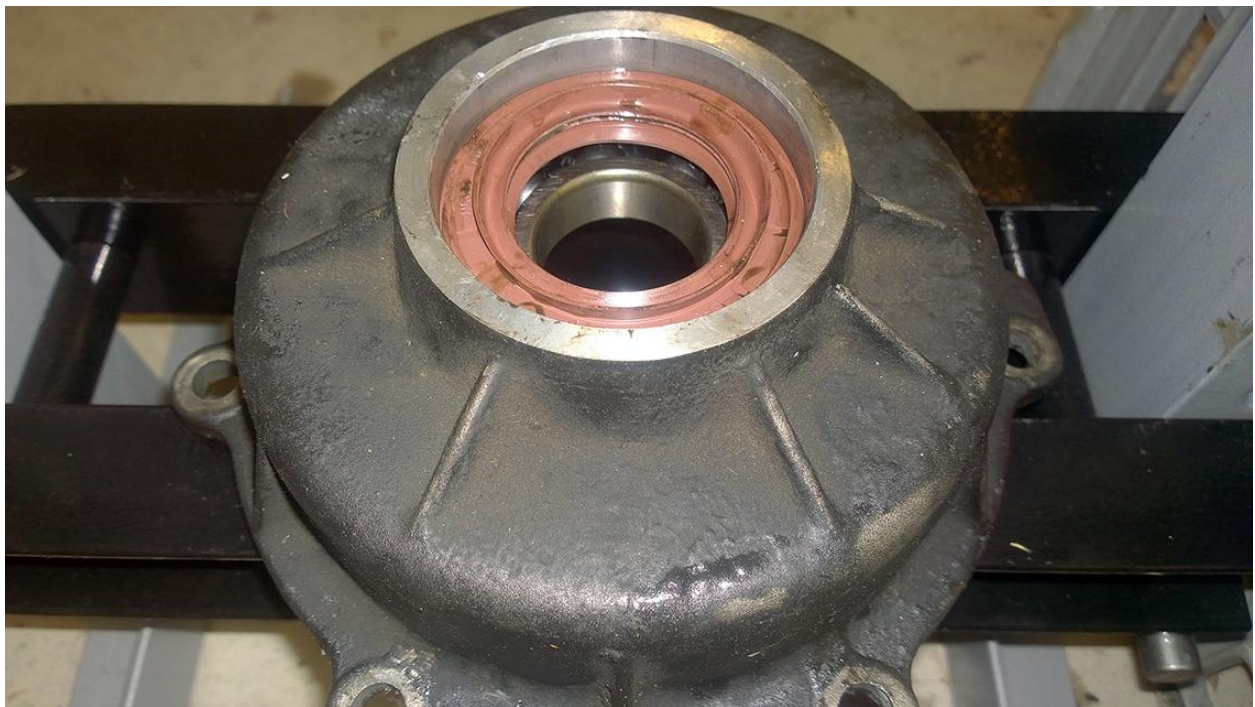
Next flip the housing over and press the new VC unit into the bearing.

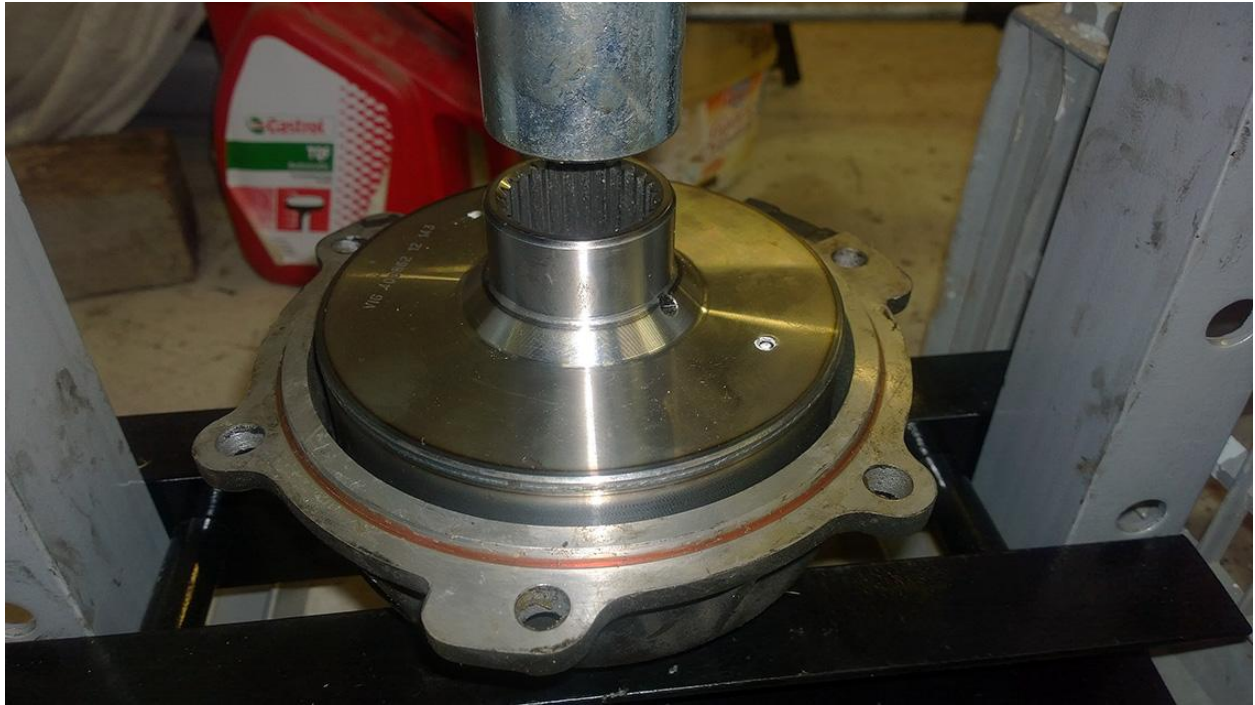
New VC pressed into place.
