P38 Range Rover viscous coupling replacement.

I could not find many photos of this job in progress, so I thought I'd share my experience for the benefit of others.

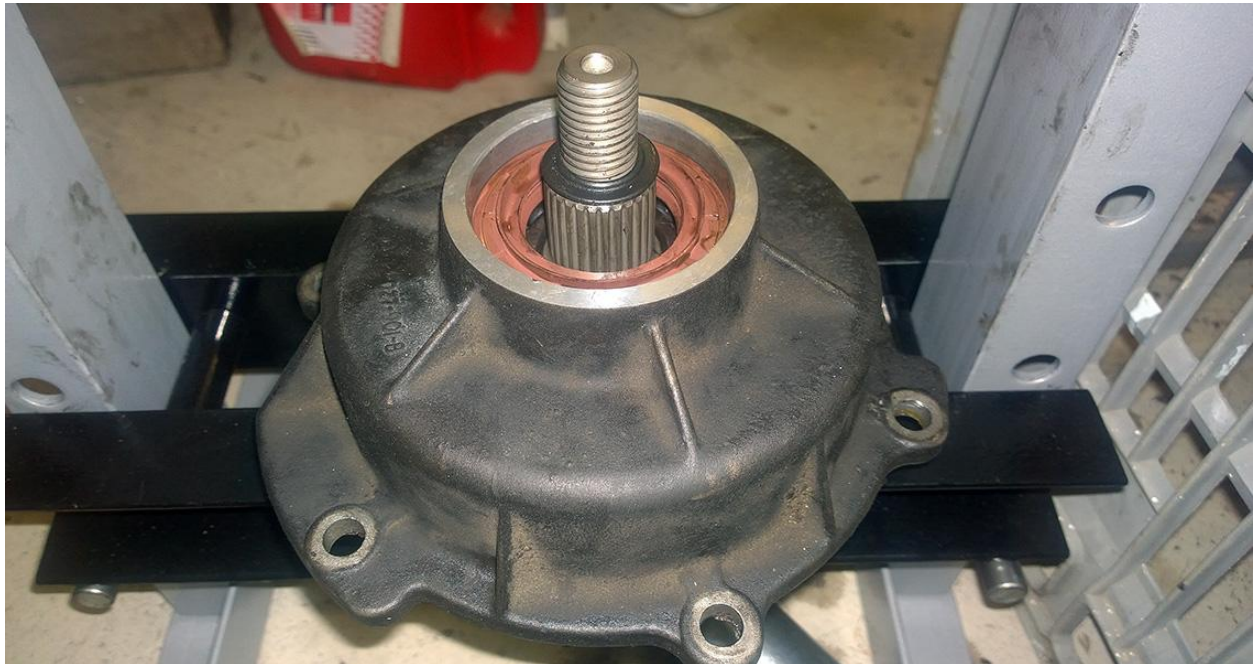
Properly clean the mating faces and apply a 2mm bead of correct grade silicone around the face, inside the bolt holes.

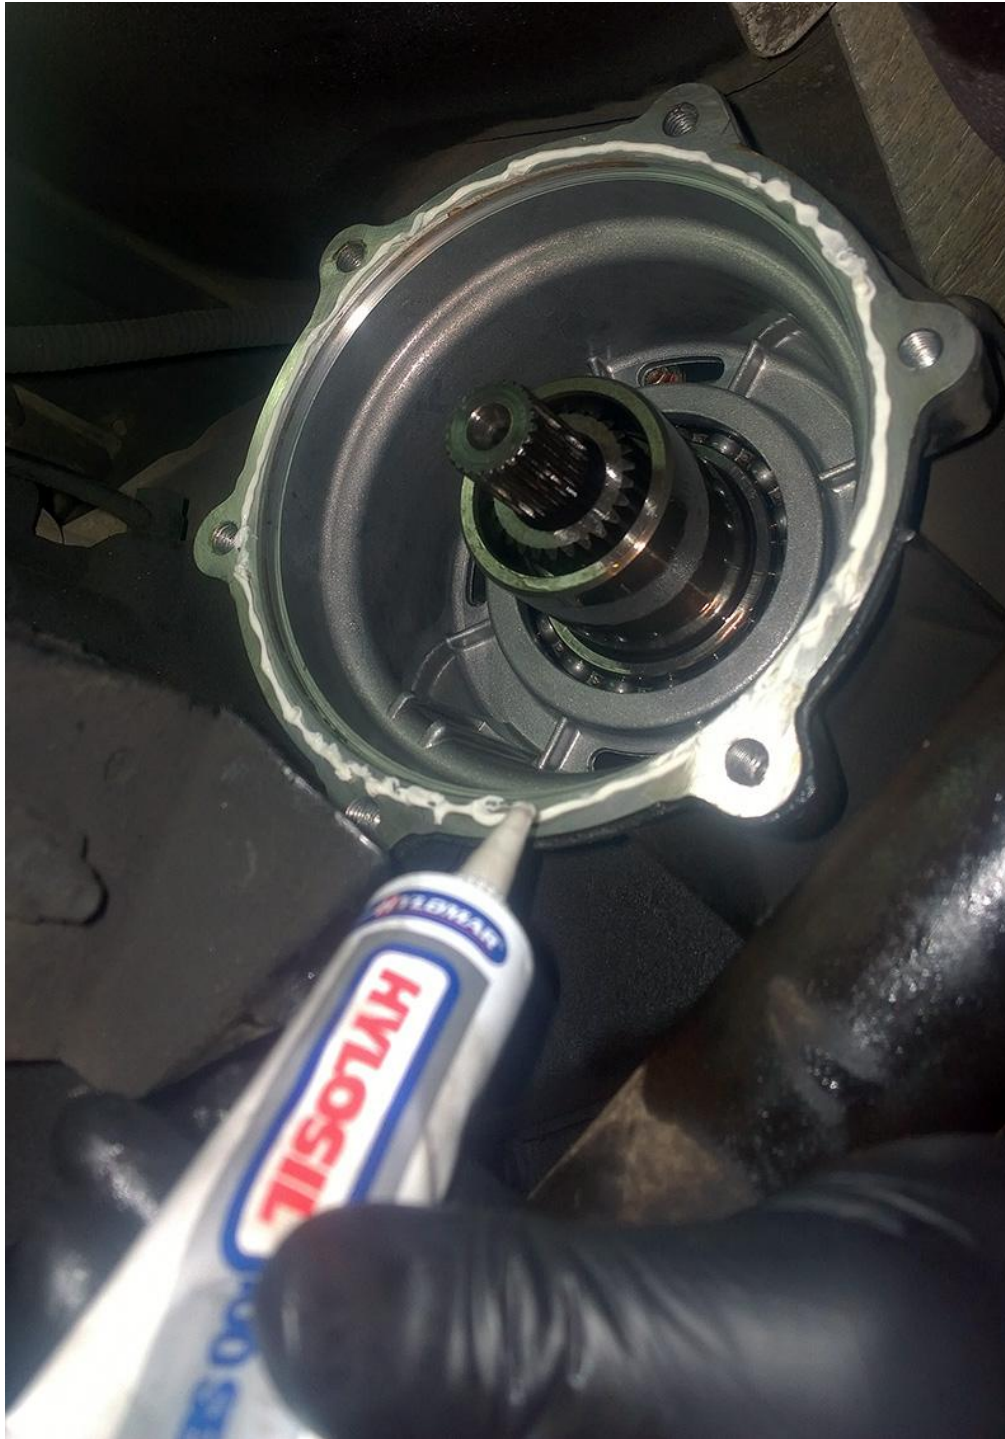
Trying your best to keep the mating faces clean, align the VC onto the shaft. It has to be in the right position to go on, you may need to wobble it around a bit to get it to engage with the shaft, but once it engages at the right angle, it will slide on easily. Take note where the bolt holes originally lined up and move the housing into position. Note the protruding part of the case on the right hand side to help you align it properly. Try to only push the mating faces together once, so the silicone bead does not get too disturbed.

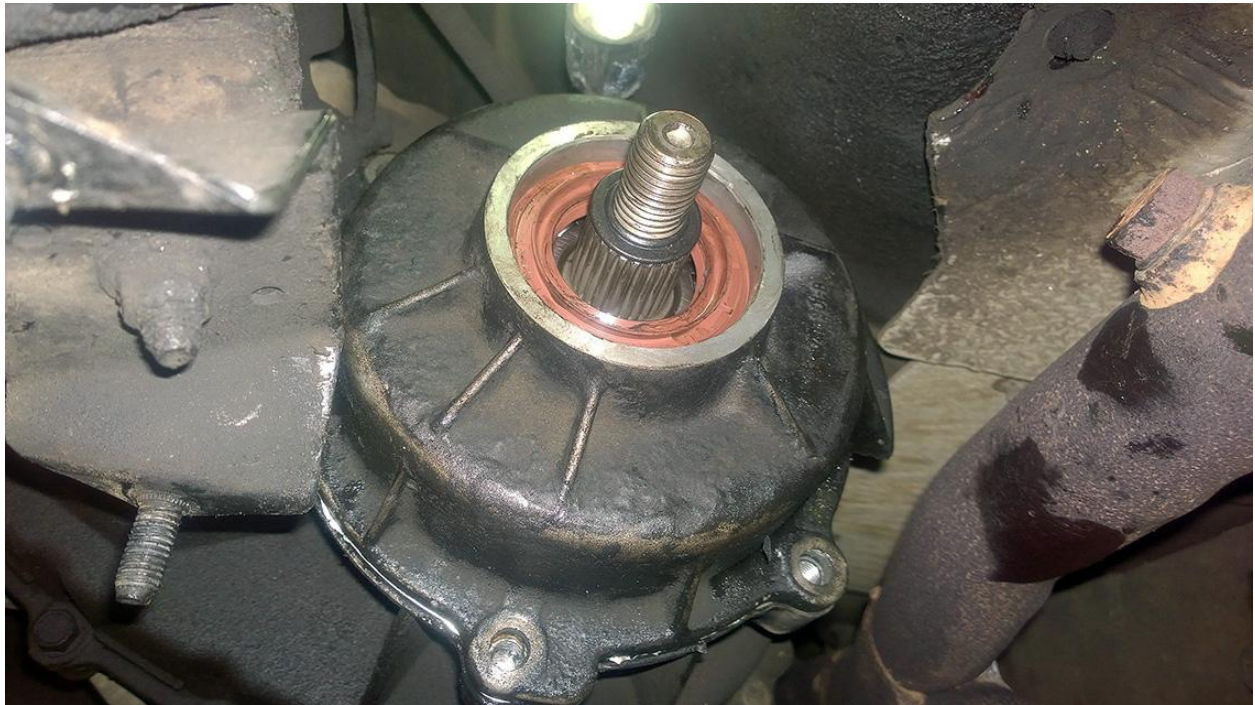
Next replace all the bolts and do them up with your hand as much as you can where possible. Next a 15mm socket on an extension will nip them up loosely.

The nut on the middle left (looking at it from the front) is in a tough spot, a 15mm open end spanner, or maybe a racheting spanner is a big help with this one.

Next torque up all 6 housing bolts to 26 Ft/Lbs, (35Nm). I used the star pattern order to torque the bolts to distribute the tension evenly.

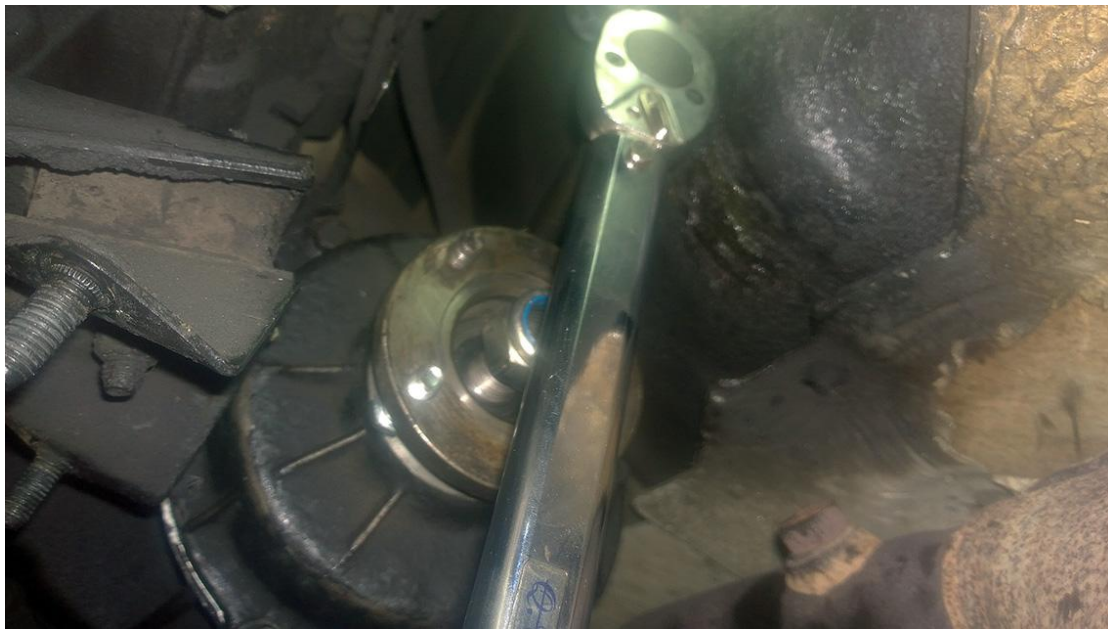
Next torque up the flange bolt to 162Ft/Lbs (220Nm) I used the same leg method as undoing. I did not need to brace the flange, but I did make sure the handbrake was applied before tightening.

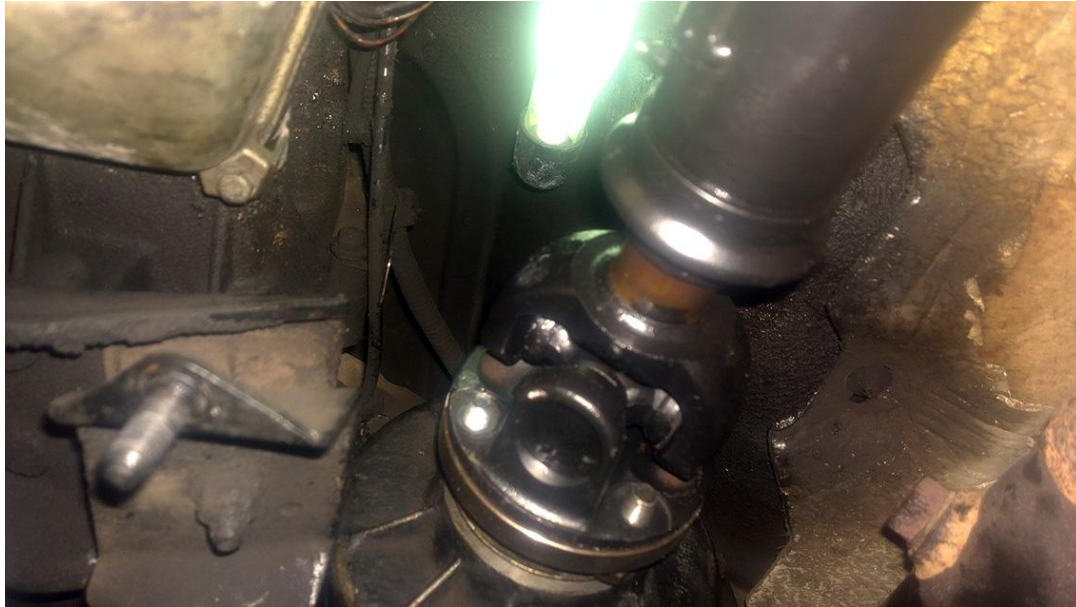
Next I located the drive shaft onto the flanges, loosely doing up a couple of bolts on each end so it didn't fall off. I figured it was easier to do that before the cross member went back on.

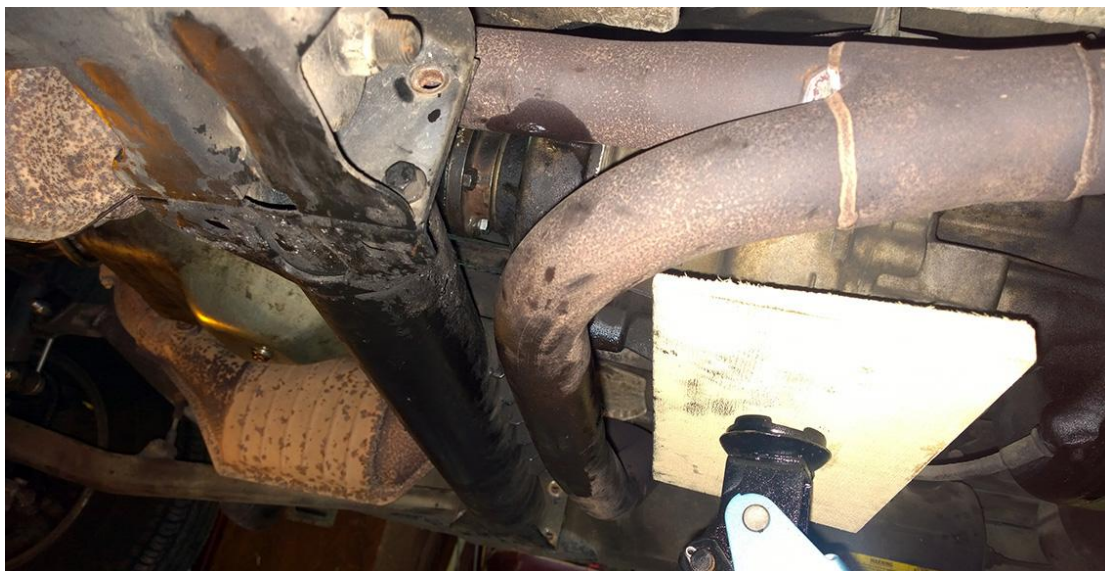
Next refit the cross member, it has to go in evenly at both ends. Mine went in without any trouble. You will need a heavy hammer to tap it back into position and line up the bolt holes. Once I got one bolt through, I put the next bolt in the hole and tapped the cross member until that bolt went through. I have heard of people having to use a jack and blocks of wood to separate the chassis slightly to get the cross member to go back into position. I'm glad I didn't need to do that.

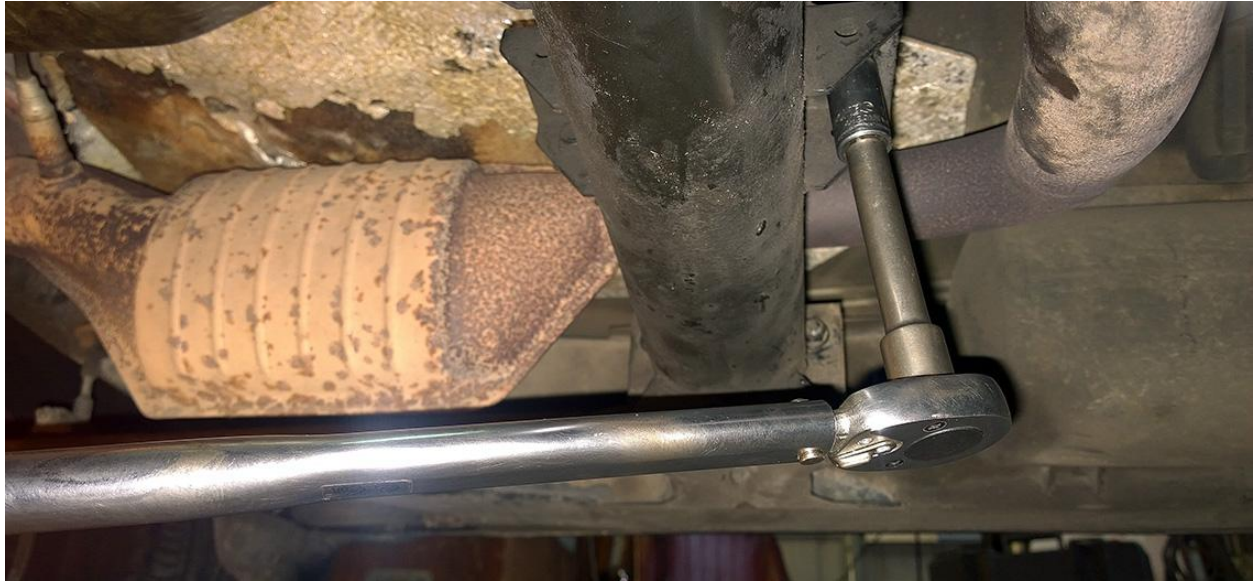
Then refit the mount bolts and nuts, torque to 33Ft Lbs (45Nm).

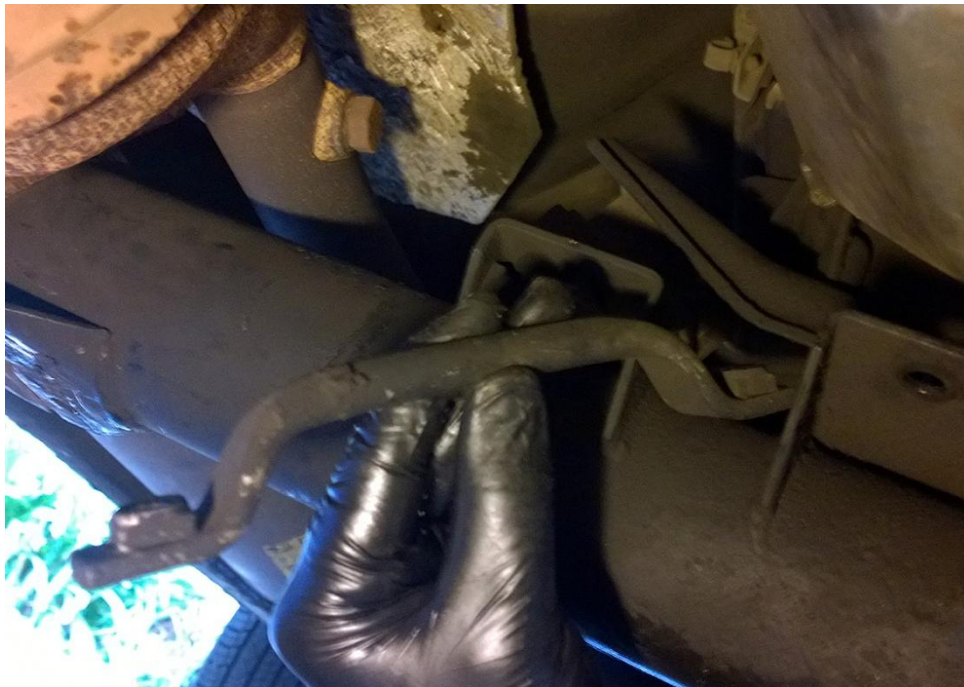
I did the snubber bar last, it goes through a hole above the center of the cross member, the 2 bolts thread into each end of it.

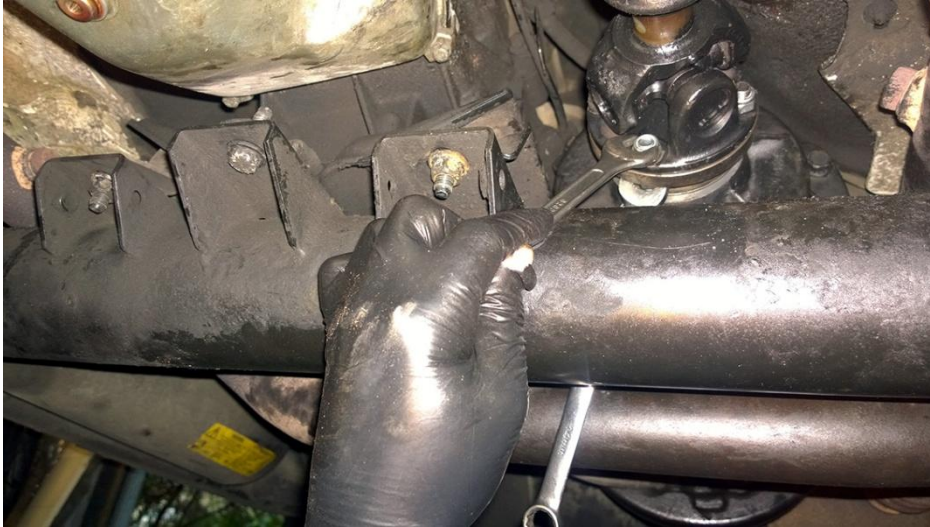
Next remove the jack that was supporting the transmission, then attach and tighten the drive shaft flange bolts at front and rear. You will be getting tired at this stage, be patient, you are nearly there! Again I ended up rolling the vehicle forward to access each nut in turn.

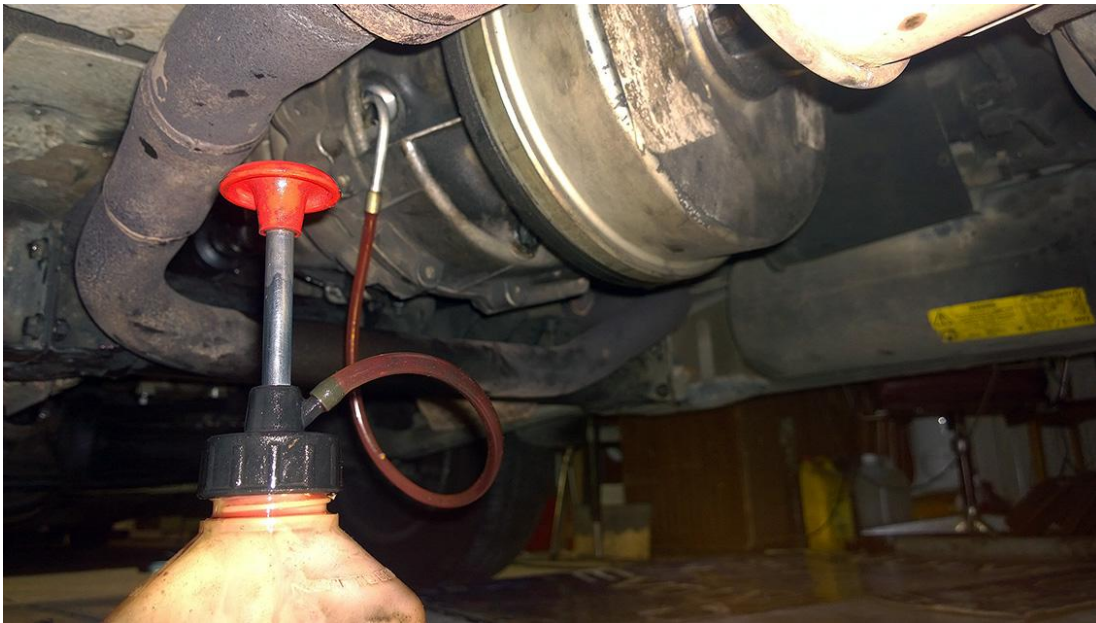
Last but not least, refill the transfer case with correct ATF and refit the plug.
